# **USAAMRDL TECHNICAL REPORT 73-74**

## **EVALUATION OF VARIOUS SIZES AND CONFIGURATIONS OF FUEL TANKS**

**CONTRACT DAAJ02-71-C-0031**

**FIRESTONE COATED FABRICS COMPANY**

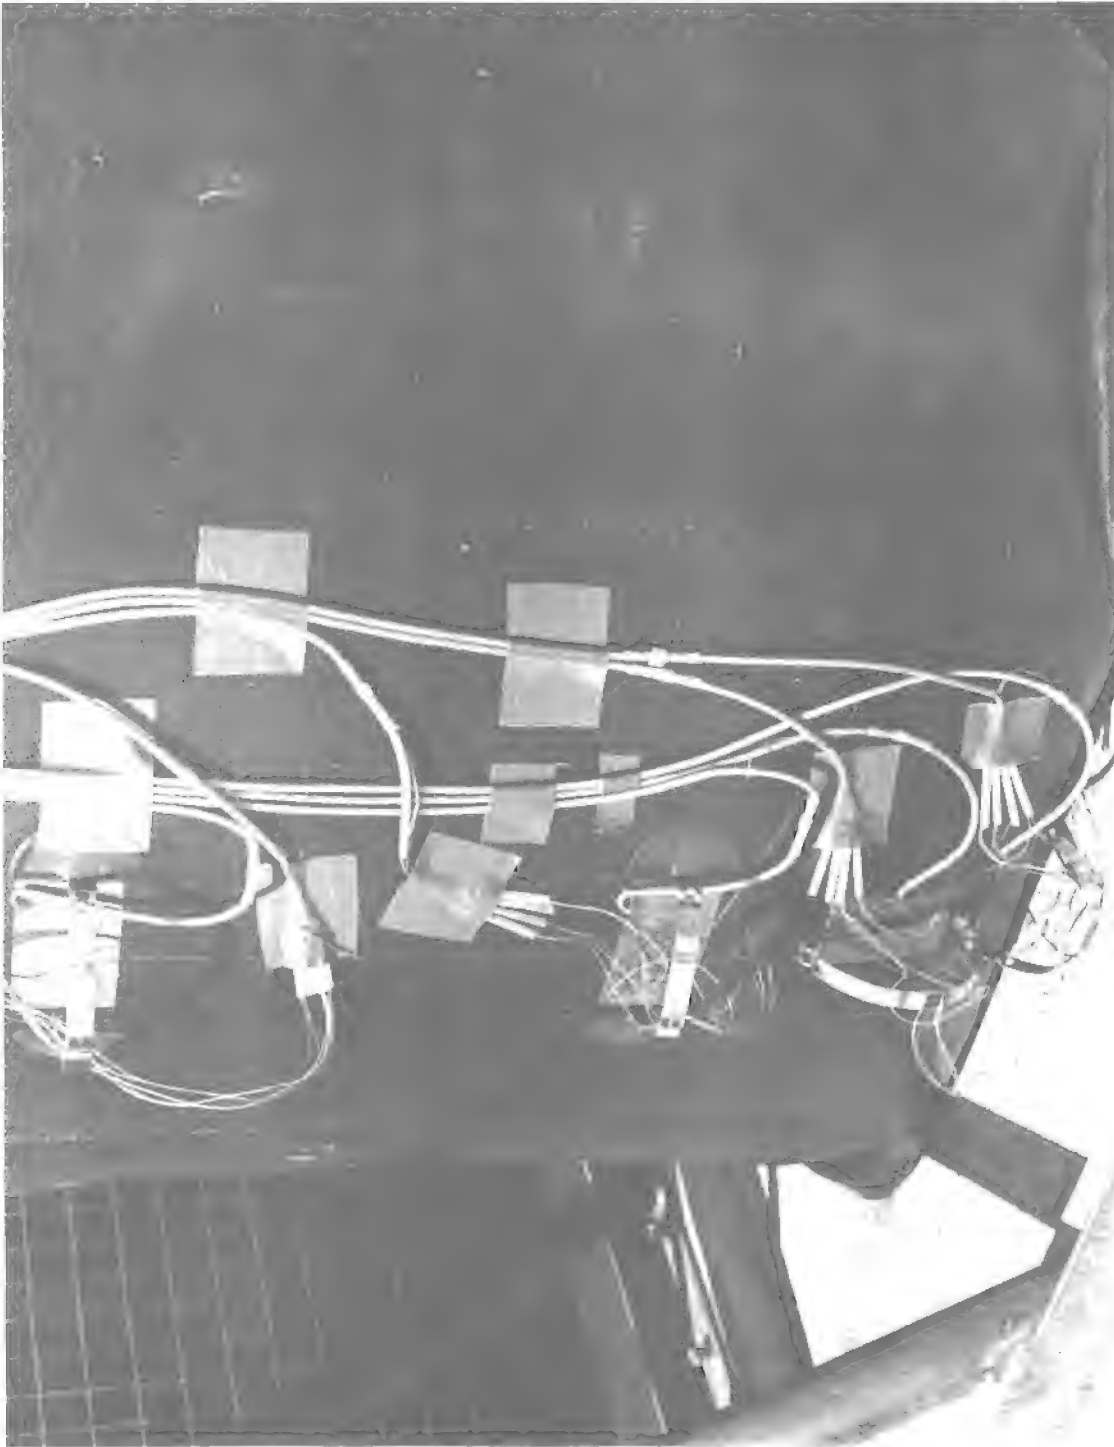
Figure 23. Full-Bridge Clip Extensometers

Separate special mounting pads at each end of the clip extensometers permitted individual mounting of each end of the extensometers and freedom of movement of the tank wall. Difficulties were encountered, however, in two areas with these extensometers. First, the inertia of the bowed metal projecting outward from the tank wall produced high bending moments at the mounting pad which frequently tore the extensometer from the pads during the contortions of the tank upon impact. Some of these were found as far as 50 feet from the tank. Attempts made to redesign and reinforce the mountings improved the condition, but never entirely corrected it.

Second, extensometers located near the tank impact face were trapped between the tank and the platform as the tank expanded upon impact. This not only obviously affected the measurement but also presented the possibility of tank damage to the point of failure since the sharp edge of the metal clip was frequently against the tank after being distorted. (See Figure 24.) In fact, one tank, Serial No. 57128, sustained a 2-inch cut through the inner liner, but did not tear. Leakage of water was minimal, and the tank successfully sealed as long as the wound was not misaligned. Photographs of the damaged tank as it came to rest are given in Figures 25 and 26. Because of the above difficulties, testing was suspended at that point until a more satisfactory strain gage could be devised.

A slide wire extensometer was then designed to replace the other gages. Although this extensometer would not permit continuous readout since it was limited to measuring increasing elongation,

approval was received for its use for the reason that it had not been possible to attain continuous readout with either of the two previously tried gages. The slide wire extensometer also eliminated the hazard of tank damage and improved somewhat the certainty of obtaining maximum strain readings on the tank wall. An instrumented tank is shown in Figure 27.
